Inspection Report

Inspection Address

30 Baker Dr, Tenambit, NSW, 2323

This report documents building defects identified during an inspection conducted in accordance with Part 1 of the Australian Standard AS 4349 2007 (Inspection of Residential Buildings).

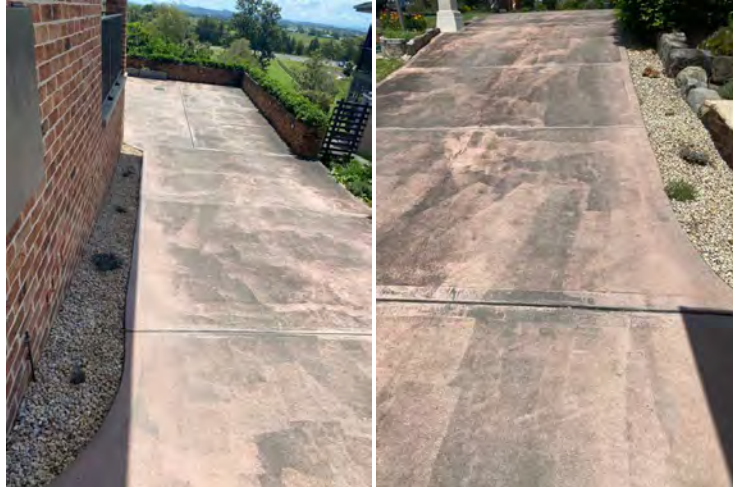
Driveway Condition

The driveway is in generally fair condition for the age and type.

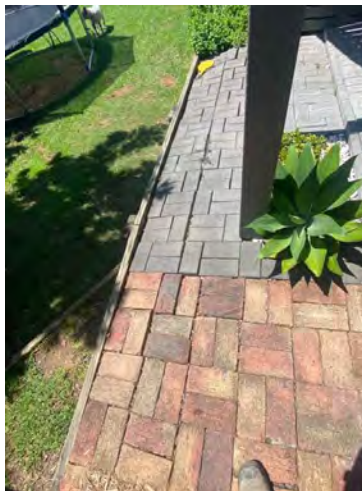
Pathway Condition

Cracking and/or settlement was observed within the pathways and/or patios. Despite this, the pathways/patios are considered to be in typical condition for pathways of similar age and construction type. Recommend repair as necessary by a licensed tradesman.

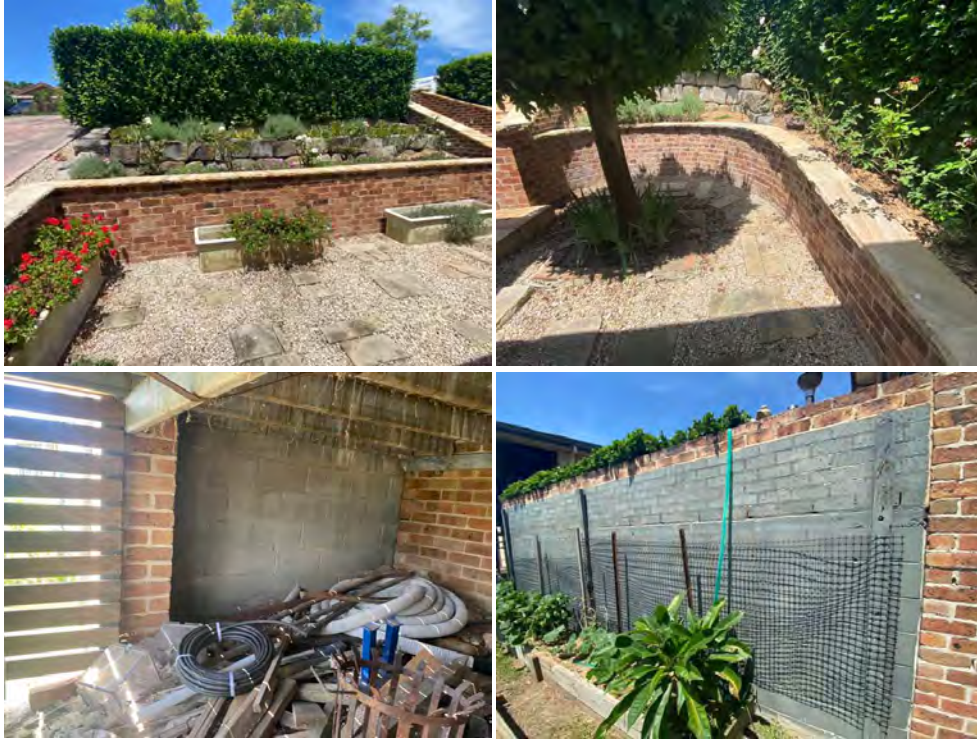
There are masonry retaining walls within the property and/or along the boundaries.

Retaining walls within the property are generally sound and fit for purpose. Note that only retaining walls which support elements of the building, and landscaping walls greater than 700mm in height were inspected. This is in accordance with AS 4349.

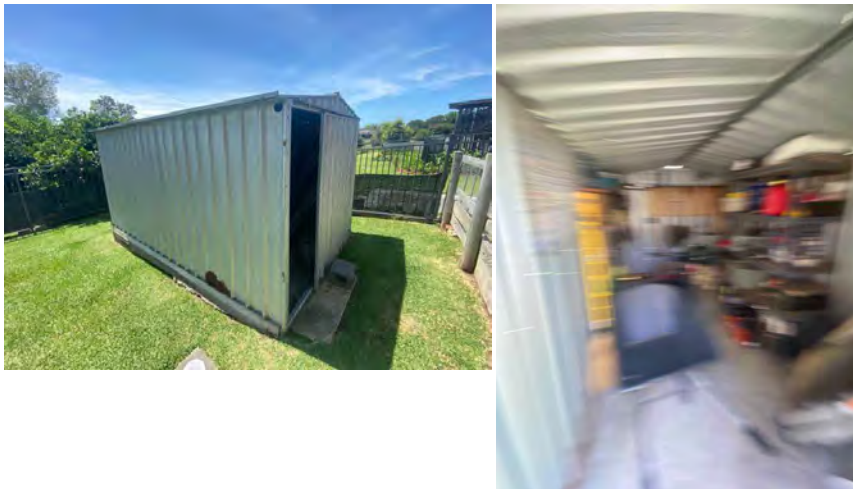
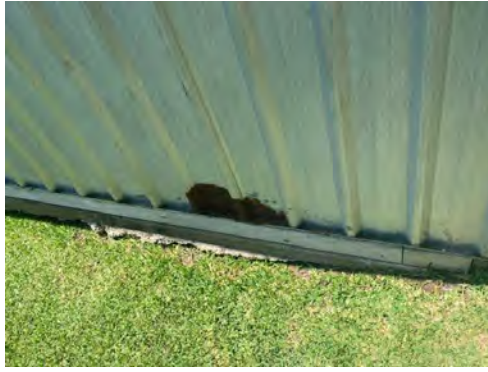
An isolated shed building stands to the northwest of the house.

The isolated building has minor deterioration but is in typical condition for its age and type.

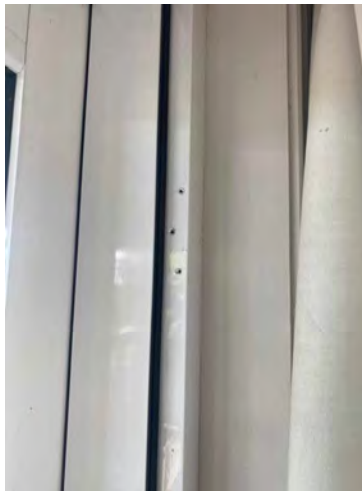
The external doors of the building are in a generally fair condition overall and fit for purpose. However, there were some observations (e.g. minor damage/holes in some jambs). Recommend general maintenance and repair as necessary by a licensed tradesman. In some instances components may need to be replaced.

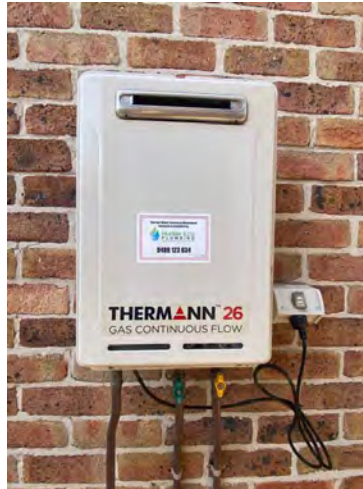
The hot water system appears to be in a serviceable condition. No specific tests other than running the hot water from a tap was carried out. No determination has been made as to the suitability or adequacy of the hot water system in relation to capacity or otherwise.

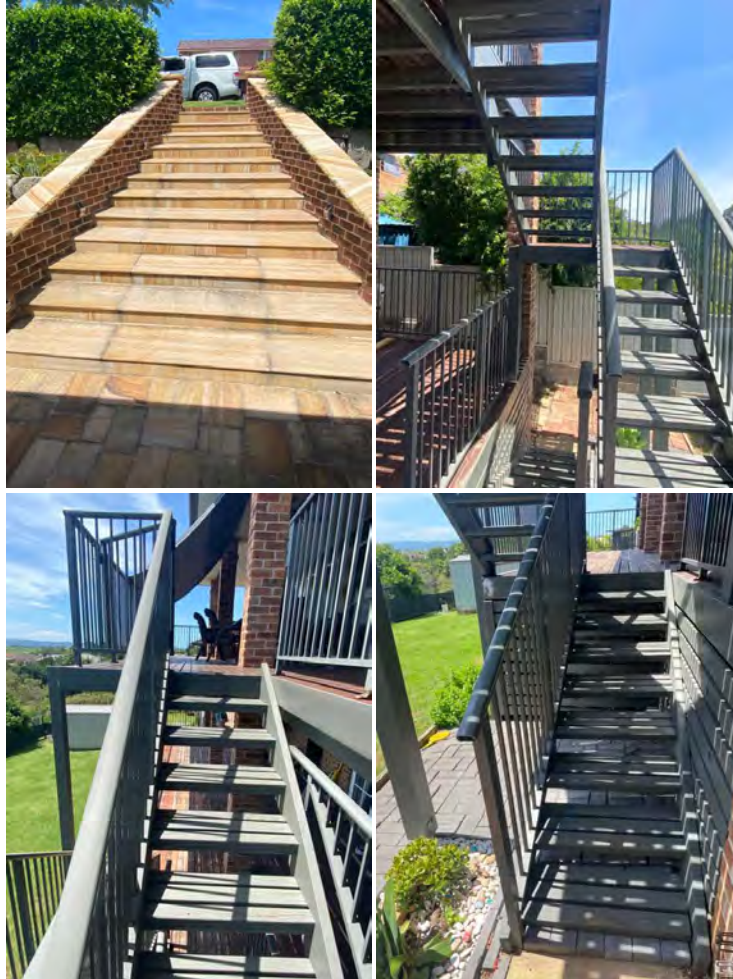
External stairs to the building are in a generally fair condition for their age and type, and appear serviceable.

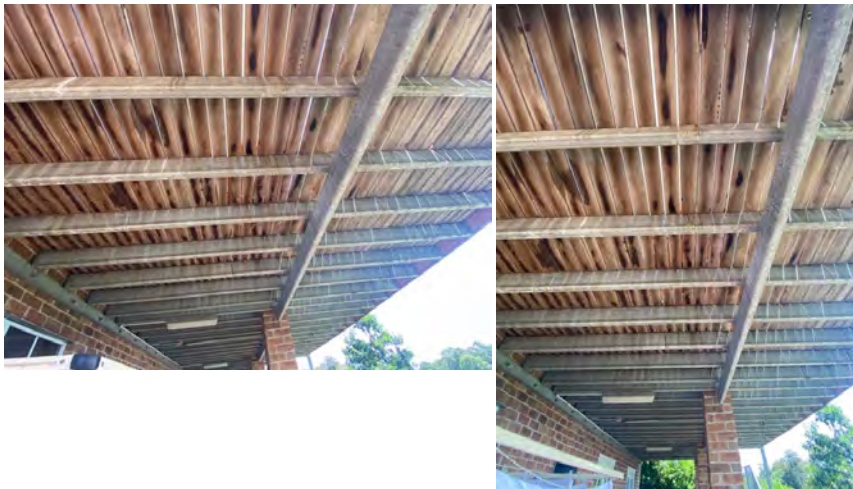
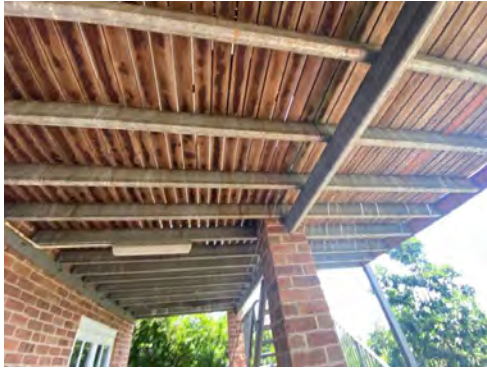
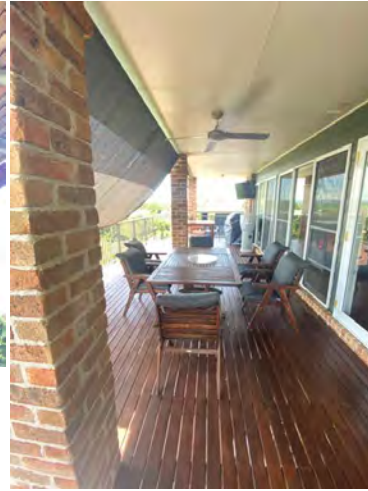
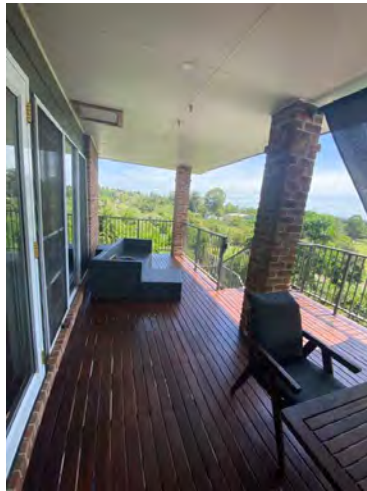
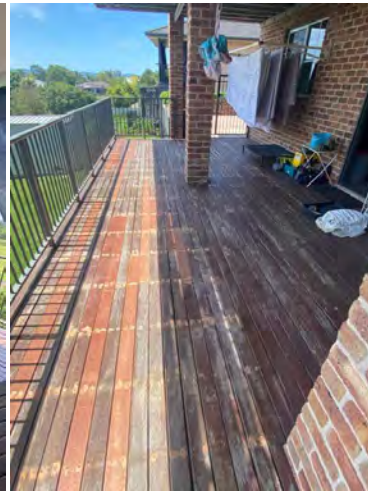
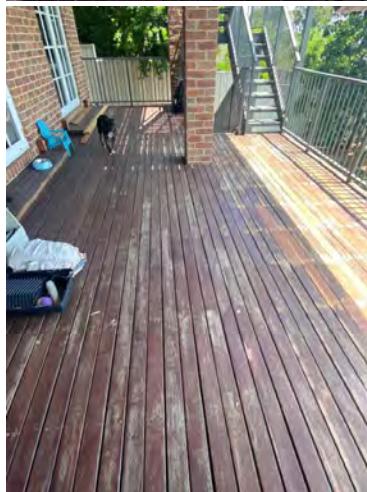
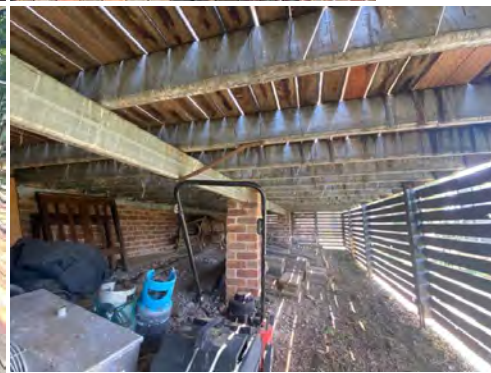
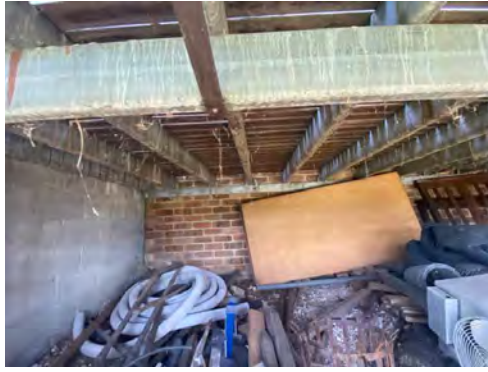
The decks to the building are in a generally fair condition for their age and type, and appears serviceable. The decks are comprised of a metal superstructure with timber decking boards.

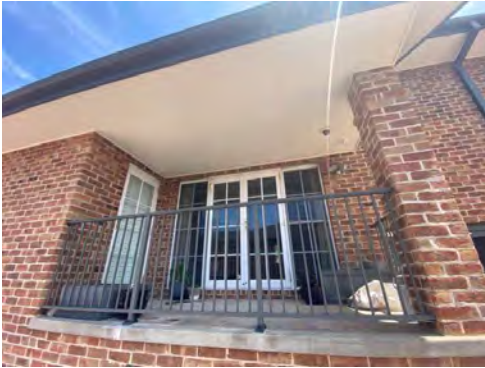
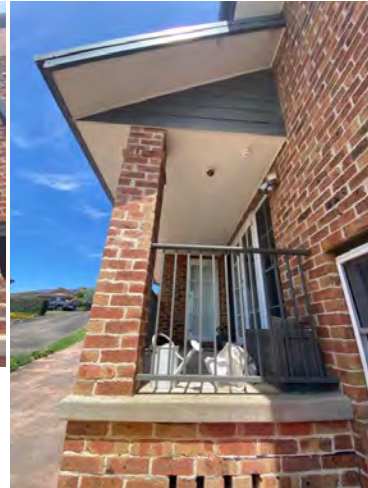
The verandahs of the building appear in fair condition for their age and type.

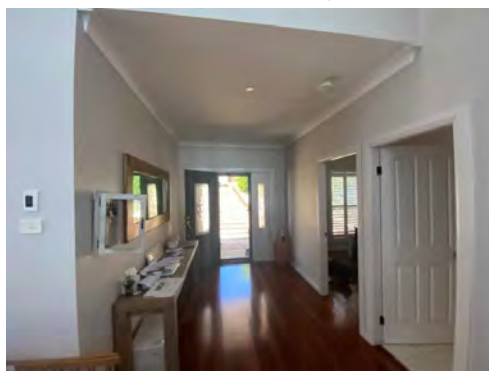
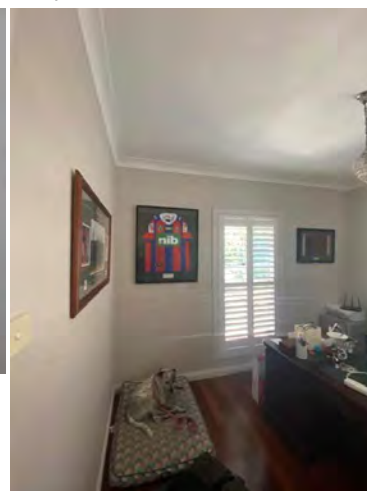
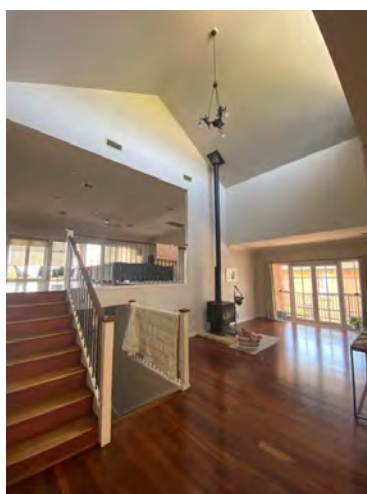
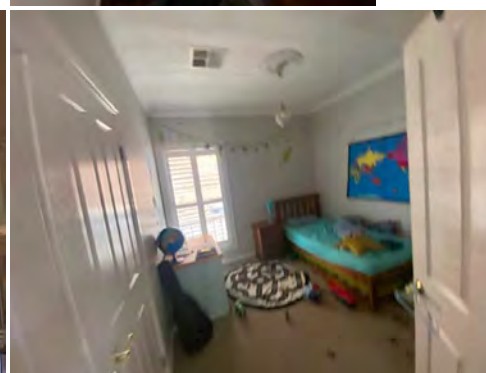
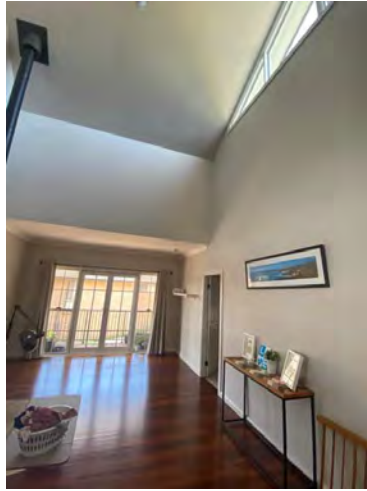
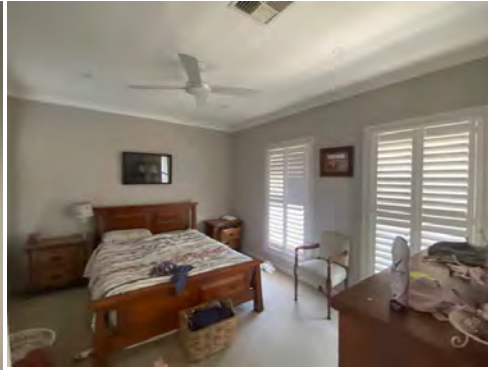
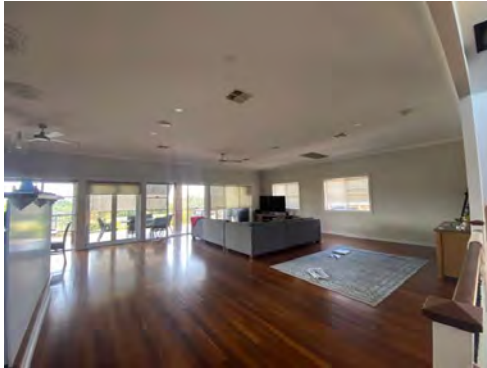
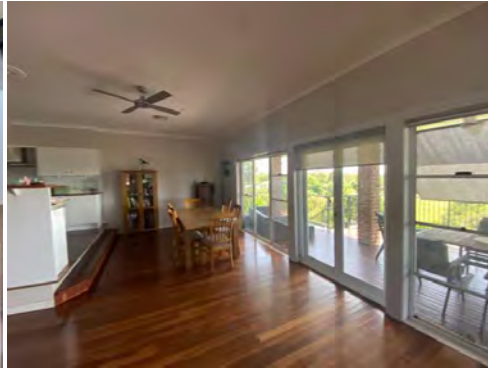
There are some observations and findings to the internal linings, trims, and finishes. This may include but are not limited to: marks, blemishes, isolated areas of minor deterioration, and/or evidence of maintenance. However, the internal walls, linings and finishes are in generally fair to good condition, and contain no significant defect. Recommend general maintenance and repair as necessary.

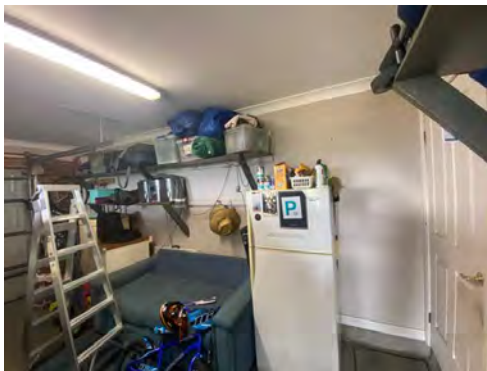
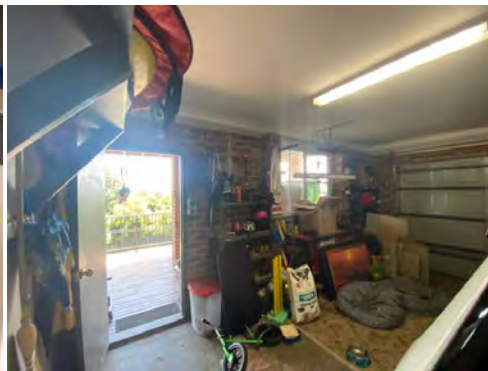
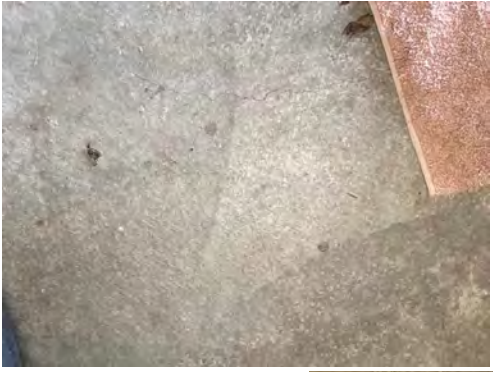
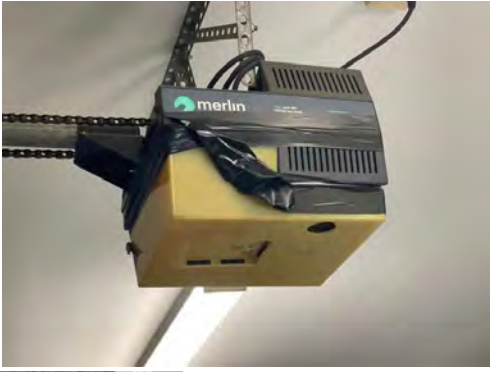
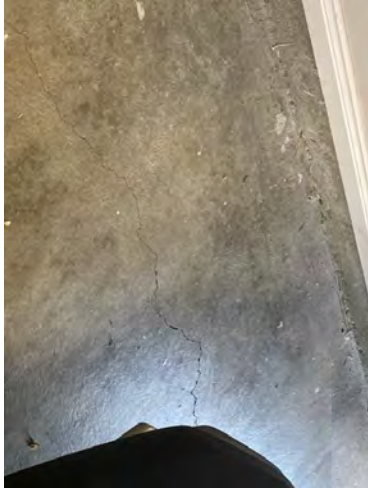
The internal linings, trims, and finishes are in generally fair condition. Recommend general maintenance and repair as necessary by a licensed tradesman.

The vehicle door was tested and operated, however the automatic door opener appeared to require maintenance. Recommend general maintenance and repair as necessary by a specialist contractor.

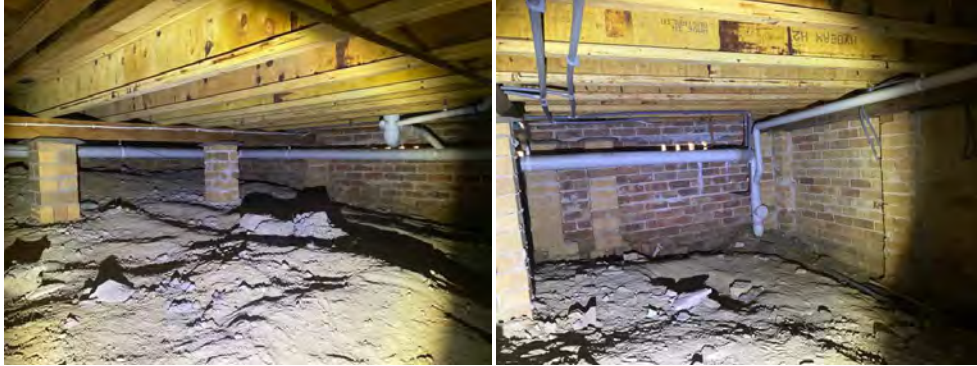
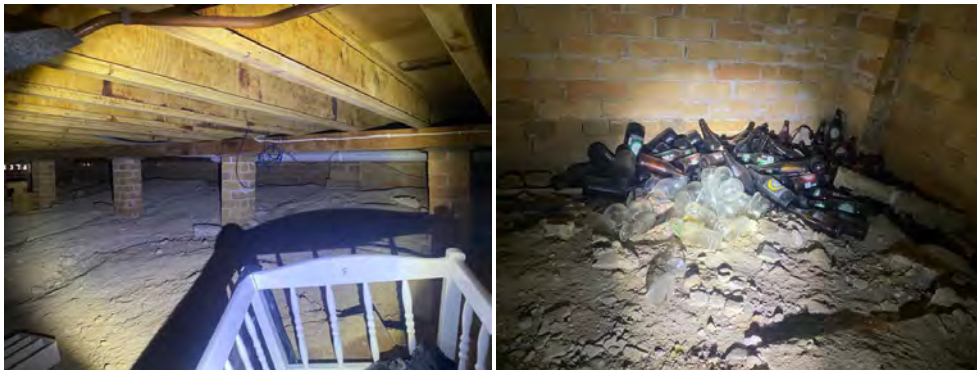
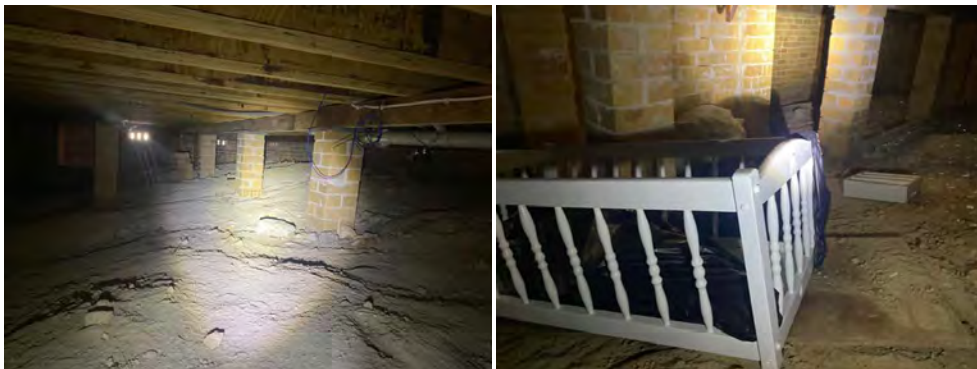
The subfloor area and substructural components of the building appeared to be in a fair condition for a building of similar age and type.

There was debris, timber, and other material in the subfloor. It is recommended removing these to aid with ventilation and reduce the likelihood of rodents and pests.
