Visual Timber Pest Inspection and Report in Accordance with AS 4349.3-2010

30 Baker Drive, Tenambit

INSPECTOR DETAILS	
Name Of Inspection Firm:	IGP Holdings Pty Ltd ACN 621 485 710, as trustee for IGP Family Trust, trading as Inspectrite Australia
Contact Phone:	0419 395 229
Technician Name:	Lance Gunther
Report Prepared Date:	04/02/2021
Work Order/Reference Number:	IA2021503

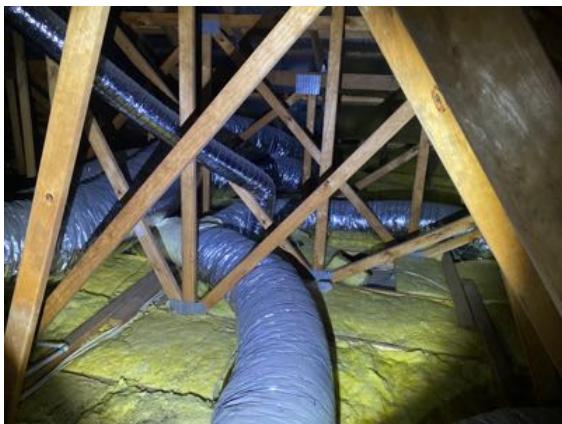
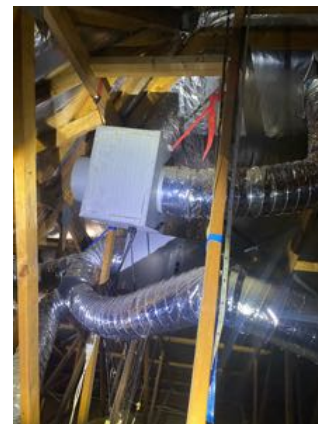
ACCESS ISSUE - Roof Void	
Access Issue Type:	Restricted Access
Reason(s) Why:	Airconditioning (Concealing), Airconditioning (Physical Prevention), Insulation, Pitch, Roof Frame

Important: If a complete inspection of the above areas was not possible, timber pest activity and/or damage may exist in these areas. Further Inspections are strongly recommended to areas where Reasonable Access is Unavailable, Obstructed or Restricted or a High Risk of possible Timber Pests and /or Damage exists.

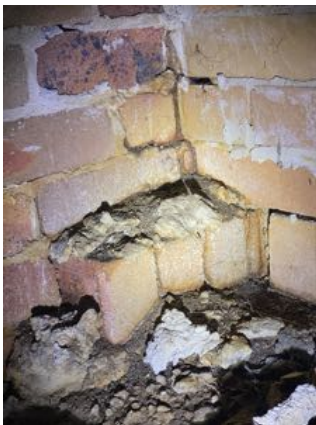
TIMBER PEST ISSUE - Subfloor	
Moisture:	Normal
Termite:	Termite Evidence Identified WARNING: SEE SECTION 3, Point 4. Refer to the advice in Section 3: Invasive Inspection
Borer:	No Borer Identified
Fungal Decay:	No Fungal Decay Identified
Location of Threats Not Limited To:	Engaged Piers, Foundation walls
Is an invasive inspection recommended?	No
Are there Major Safety Hazards Related to Timber Pests?	No Important Note: Where a Major Safety Hazard is identified above, it <u>must</u> be attended to and rectified to avoid the possibility of personal injury &/or death.

Example of termite workings on foundation walls and engaged piers, photo from beneath the eastern bedroom

A treatment to eradicate the termites and to protect the building(s) should be carried out as the risk of further attack is very high.

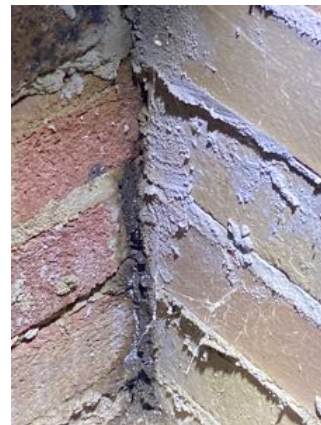
Example of termite workings on foundation walls, photo from beneath the verandah

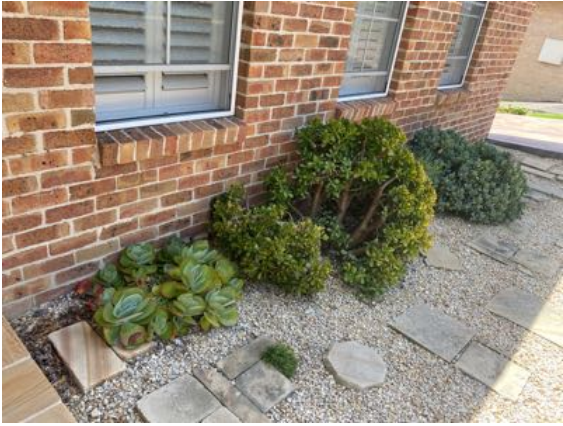
Example of vegetation located close to the building

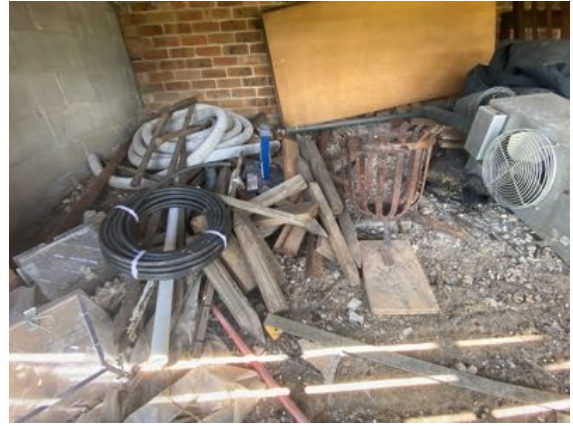
Example of timber on the ground beneath the deck.

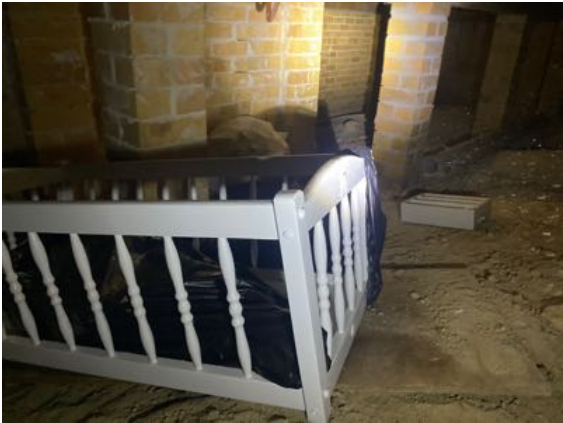
Example of timber on the ground in the subfloor

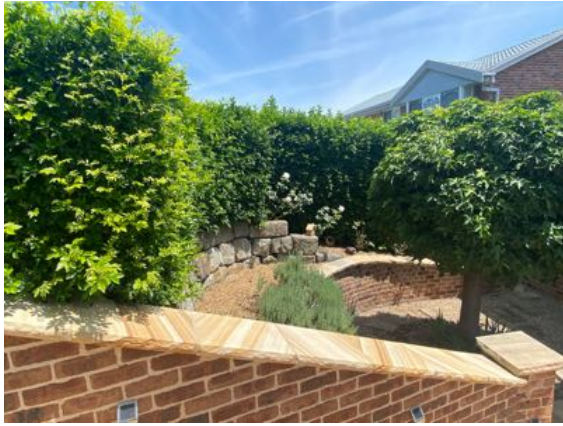
SITE CONDUCTIVE CONDITIONS PRESENT	
Conductive Conditions Present:	Yes. Vegetation on or near structures, Tree and or Stumps on site, Mulched areas

Example of trees and mulched areas on the property

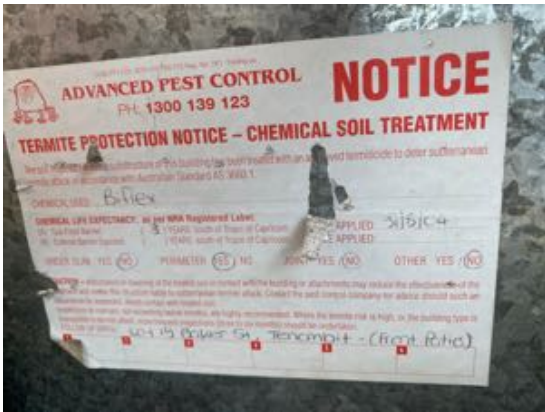
TERMITE MANAGEMENT STICKER	
Is there a Termite Management Sticker?	Yes WARNING: This firm can give no assurances with regard to work that may have been previously performed by other firms. You should obtain copies of all paperwork and make your own inquiries as to the quality of the treatment, when it was carried out and warranty information. In most cases you should arrange for a treatment in accordance with 'Australian Standard 3660' be carried out to reduce the risk of further attack.
Image of Termite Management Sticker

Termite Management Recommendation:	A termite management system has been installed by another company. It is recommended you consult that company for full details of the system installed.
Frequency of Further Inspections:	12 months
Other Inspections Recommended:	No

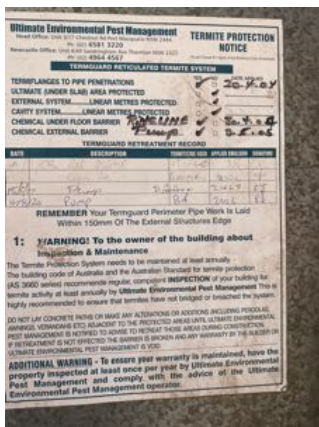
Photo Of Durable Notice

Type of Treatment:	Pre-Construction
Environmental Termite Pressure:	Level of Termite Pressure: High Overall Degree of Risk of Timber Pest Infestation: Moderate to High
