Visual Timber Pest Inspection and Report in Accordance with AS 4349.3-2010

30 Baker Drive, Tenambit

INSPECTOR DETAILS	
Name Of Inspection Firm:	IGP Holdings Pty Ltd ACN 621 485 710, as trustee for IGP Family Trust, trading as Inspectrite Australia
Contact Phone:	0419 395 229
Technician Name:	Lance Gunther
Report Prepared Date:	04/02/2021
Work Order/Reference Number:	IA2021503

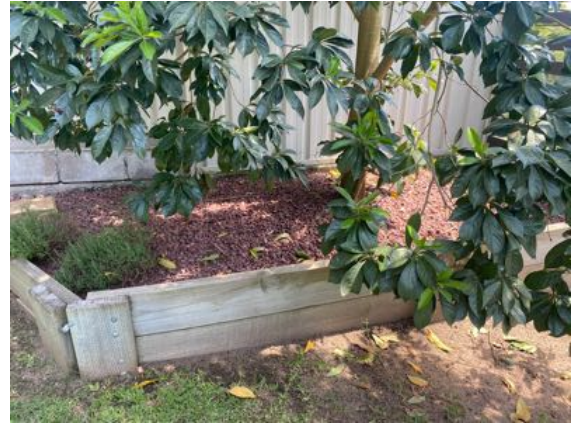
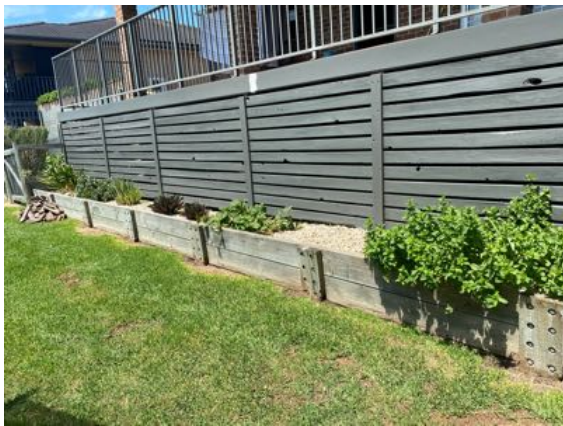
SITE CONDUCTIVE CONDITIONS PRESENT	
Conductive Conditions Present:	Yes. Vegetation on or near structures, Tree and or Stumps on site, Mulched areas
